2025/11/04 11:58 1/2 bad_solderings_gallery

This gallery shows some pictures of bad solderings - they should prevent you from making the same errors (feel free to add even more pictures here!)

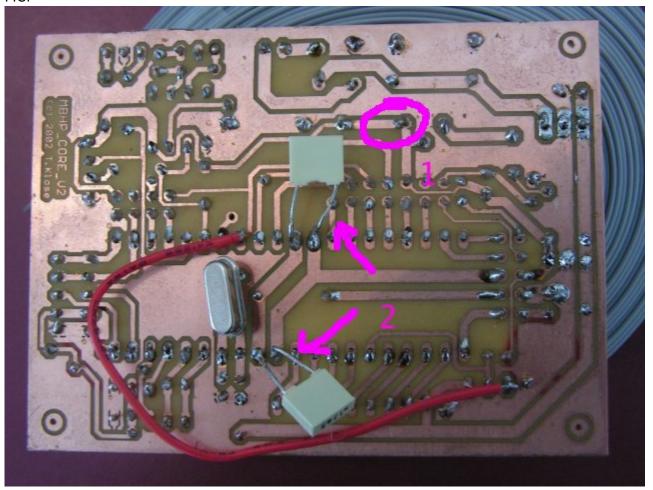
- 1: The core module has some badly soldered connections(loose), which could lead to failures. There are also missing solderings (e.g. 33pF cap below crystal). It makes sense to solder each pad again, the Soldering guide in the Wiki gives some useful tips
- 2: The legs of the caps should be cut, otherwise they can cause a short circuit which can damage the PIC!

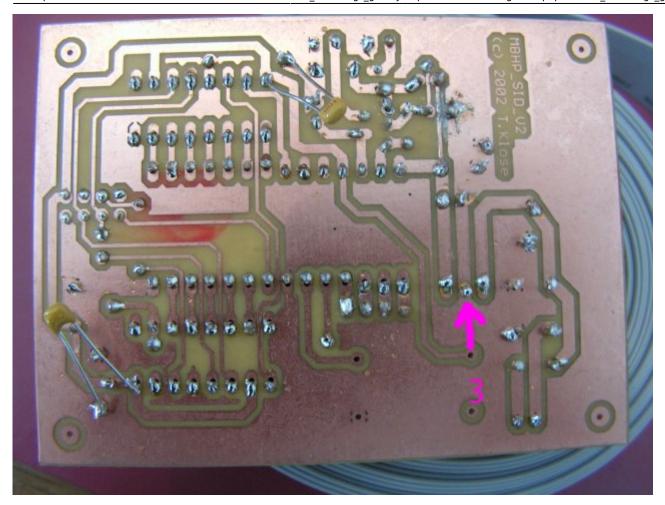
3: This seems to be a bad ground connection directly at the 78xx - it can lead to the wrong voltage. Here the same: just solder the pads again, it will help And same as above: the long cap legs need to be cut, the danger of shorting out is too high!
