2025/11/04 06:37 1/2 bad_solderings_gallery

This gallery shows some pictures of bad solderings - they should prevent you from making the same errors (feel free to add even more pictures here!)

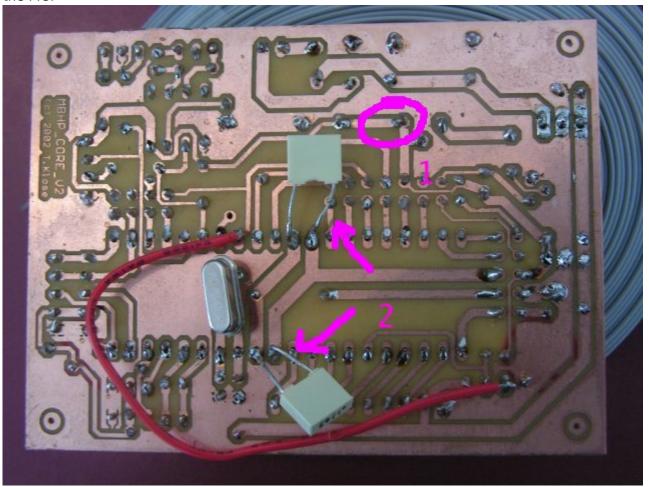
- 1: the core module has some bad solderings (loose connections), which could lead to failures. There are also missing solderings (e.g. 33pF cap below crystal). It makes sense to solder each pad again, the Soldering guide in the Wiki gives some useful tips
- 2: the legs of the caps should be cutted, otherwise they can cause a short circuit which can damage the PIC!

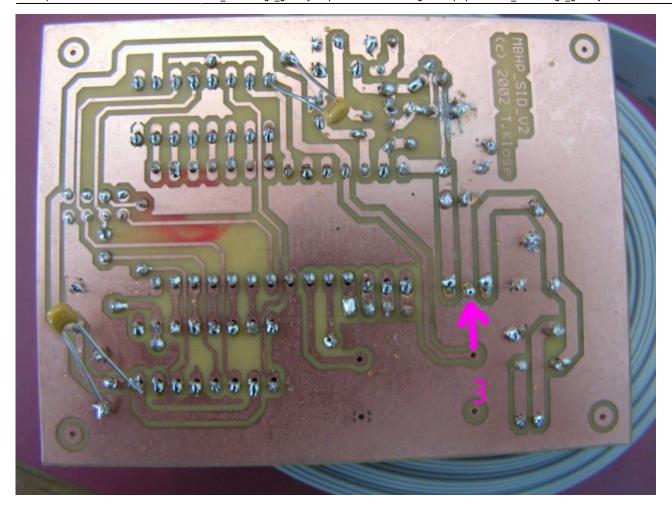
3: this seems to be a bad ground connection directly at the 78xx - it can lead to the wrong voltage. Here the same: just solder the pads again, it will help And same like above: the long cap legs need to be cutted, the danger for shorts is too high!
