This gallery shows some pictures of bad solderings - they should prevent you from making the same errors (feel free to add even more pictures here!)

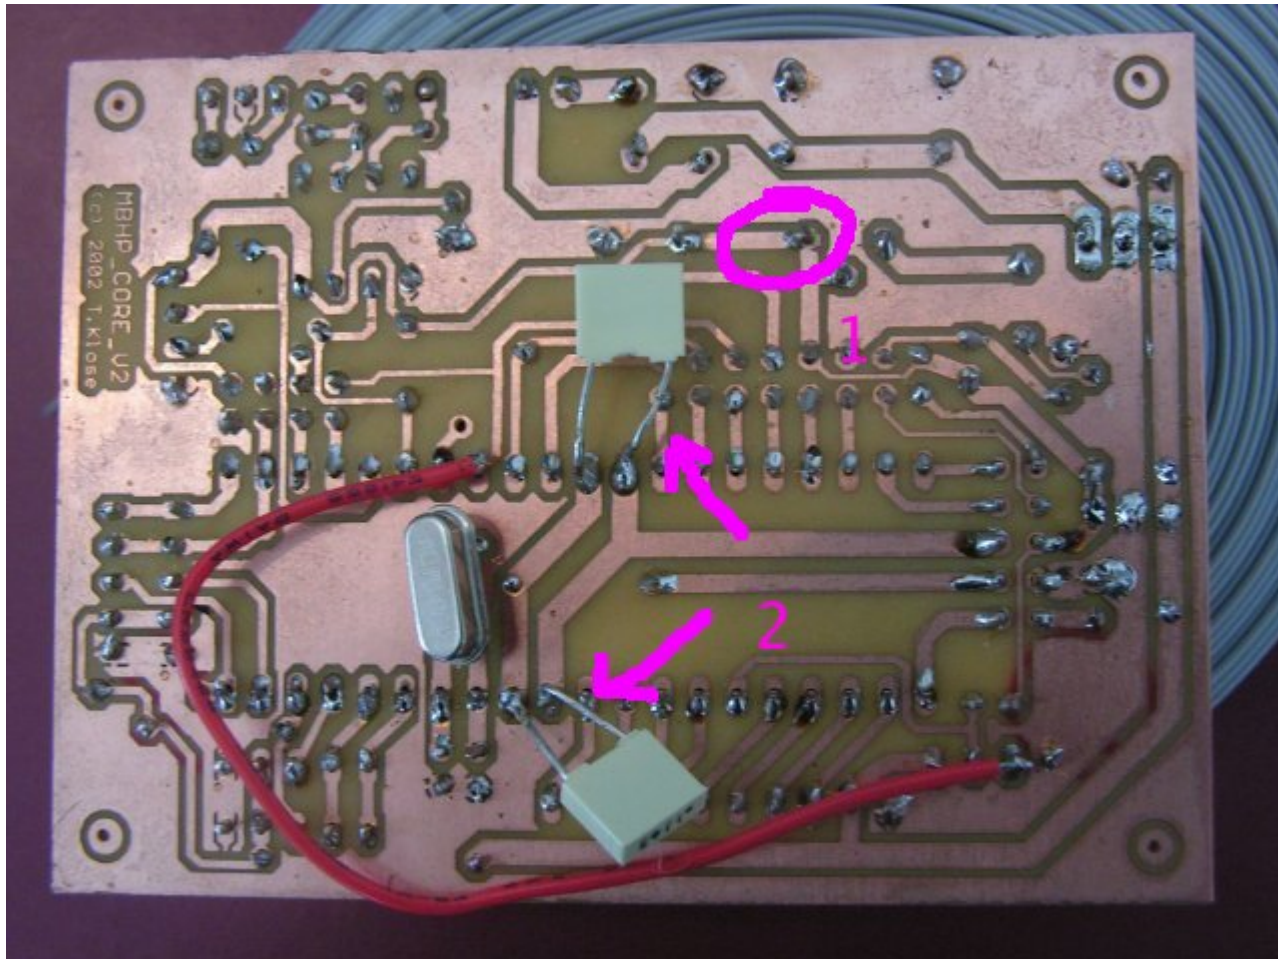
1: the core module has some bad solderings (loose connections), which could lead to failures. There are also missing solderings (e.g. 33pF cap below crystal). It makes sense to solder each pad again, the [Soldering](#) guide in the Wiki gives some useful tips

2: the legs of the caps should be cutted, otherwise they can cause a short circuit which can damage the PIC!
