This gallery shows some pictures of bad solderings - they should prevent you from making the same errors (feel free to add even more pictures here!)

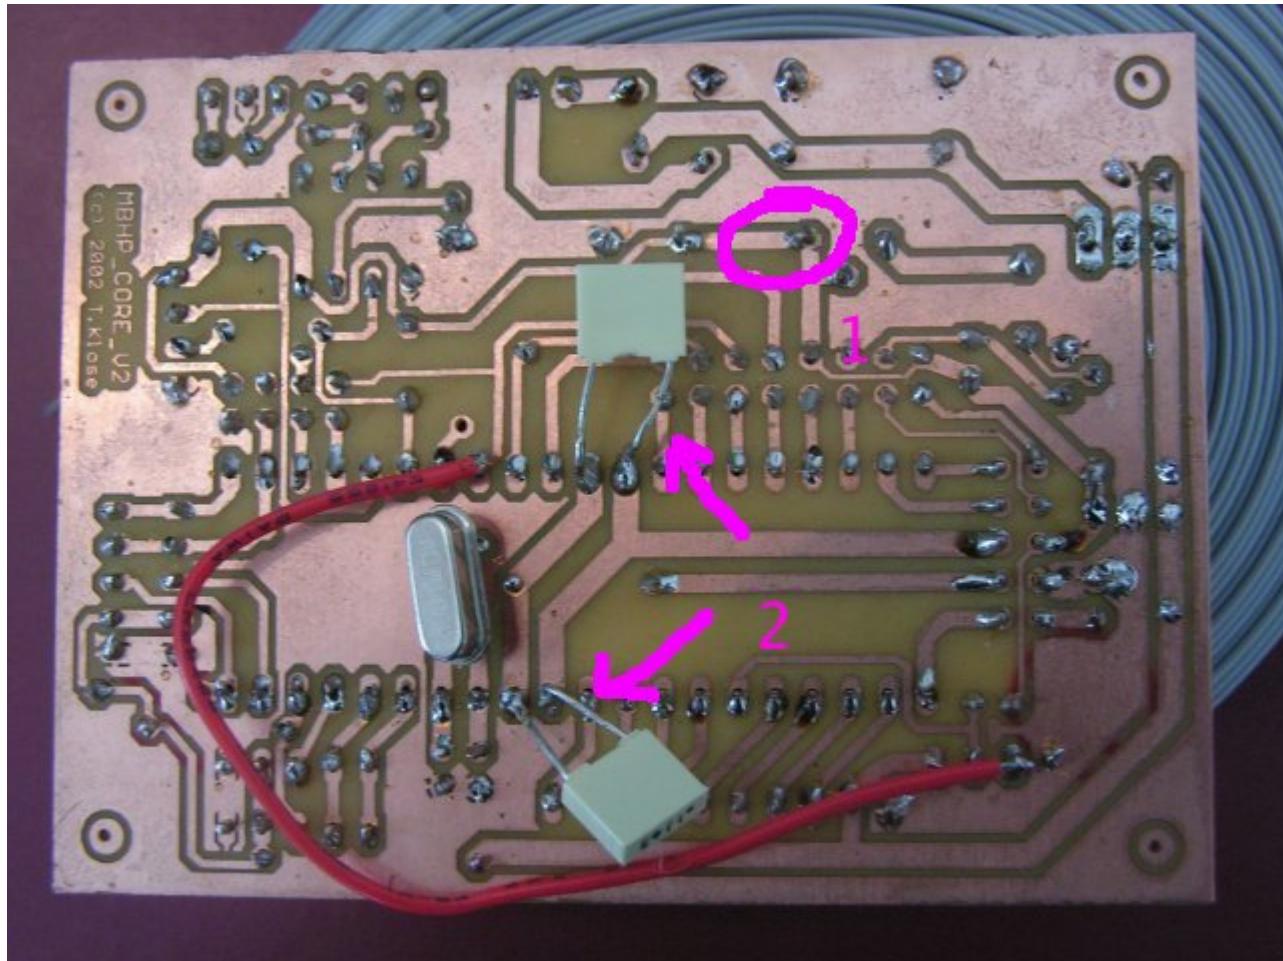
1: The core module has some badly soldered connections (loose), which could lead to failures. There are also missing solderings (e.g. 33pF cap below crystal). It makes sense to solder each pad again, the [Soldering](#) guide in the Wiki gives some useful tips

2: The legs of the caps should be cut, otherwise they can cause a short circuit which can damage the PIC!

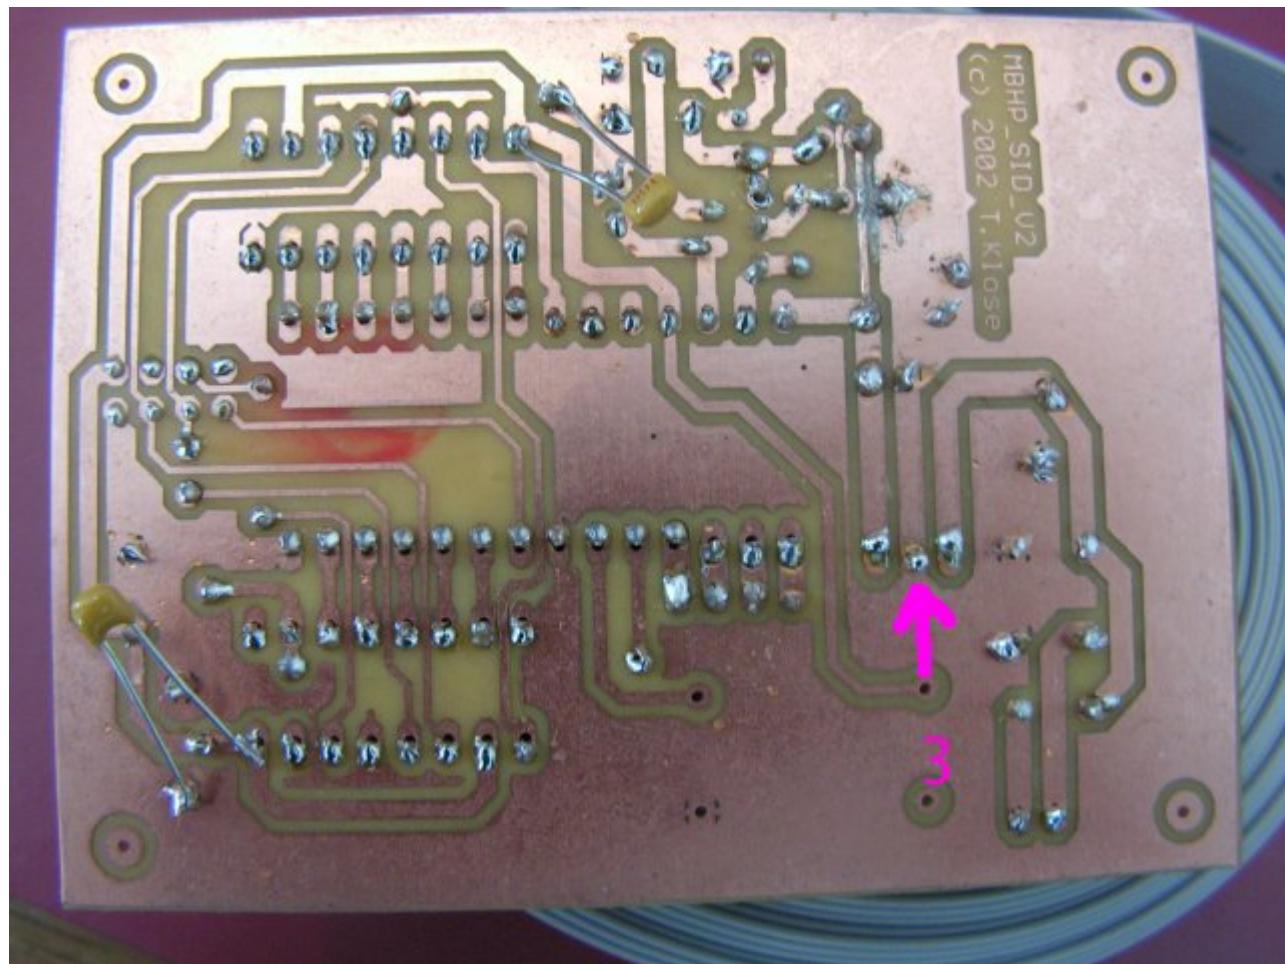
3: This seems to be a bad ground connection directly at the 78xx - it can lead to the wrong voltage. Here the same: just solder the pads again, it will help

And same as above: the long cap legs need to be cut, the danger of shorting out is too high!
