This gallery shows some pictures of bad solderings - they should prevent you from making the same errors (feel free to add even more pictures here!)

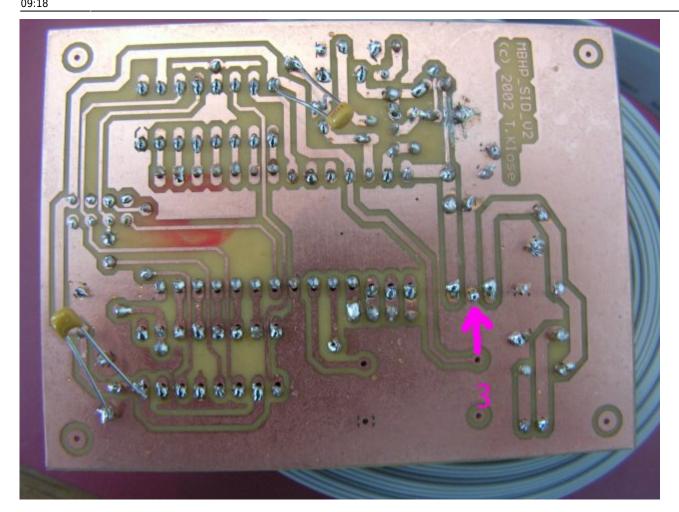
3: This seems to be a bad ground connection directly at the 78xx - it can lead to the wrong voltage. Here the same: just solder the pads again, it will help And same as above: the long cap legs need to be cut, the danger of shorting out is too high!
