This gallery shows some pictures of bad solderings - they should prevent you from making the same errors (feel free to add even more pictures here!)

Permanent link:
https://wiki.midibox.org/doku.php?id=bad_solderings_gallery

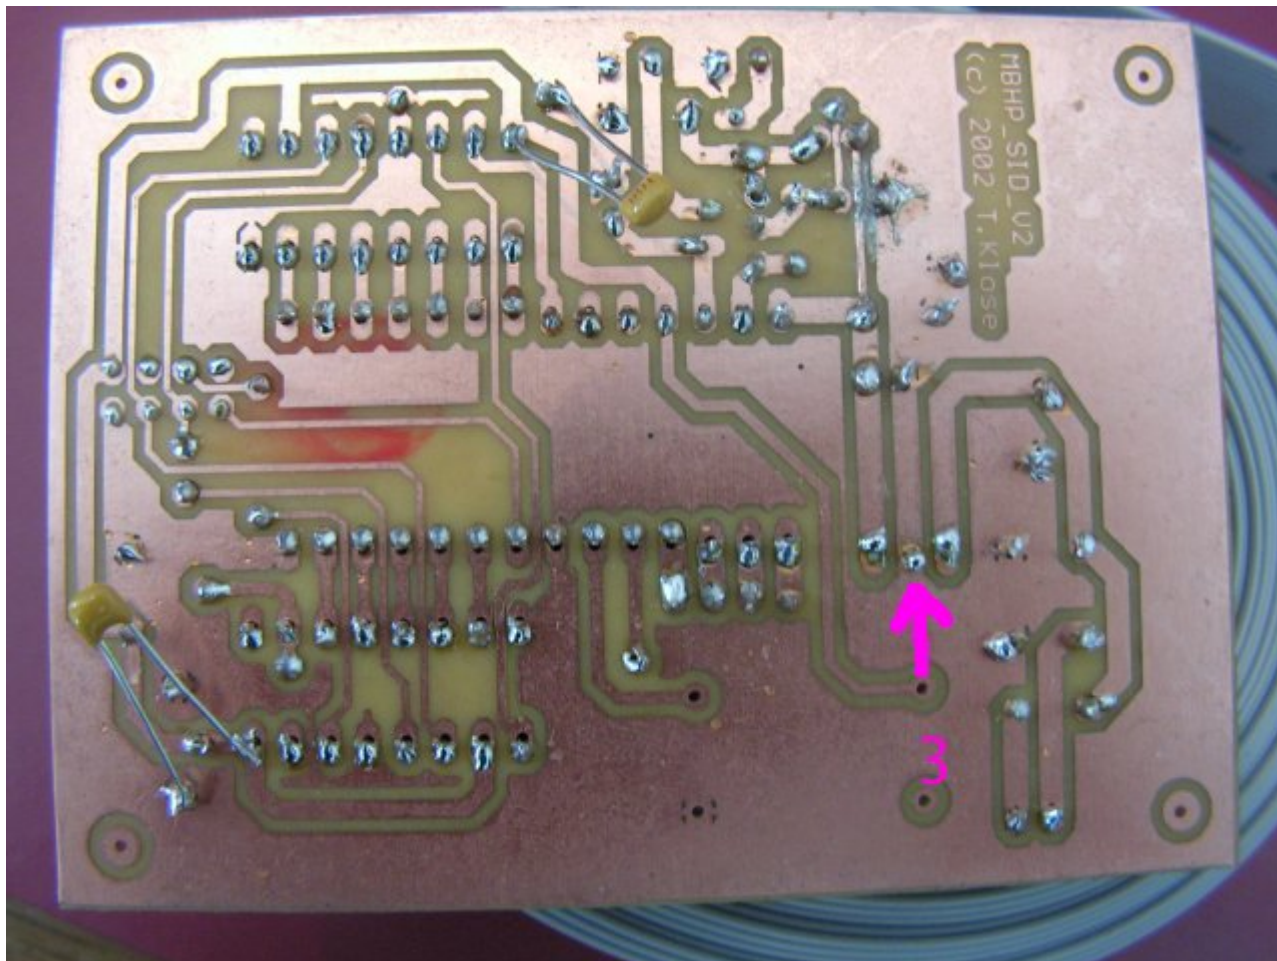
3: This seems to be a bad ground connection directly at the 78xx - it can lead to the wrong voltage. Here the same: just solder the pads again, it will help
And same as above: the long cap legs need to be cut, the danger of shorting out is too high!
