This gallery shows some pictures of bad solderings - they should prevent you from making the same errors (feel free to add even more pictures here!)

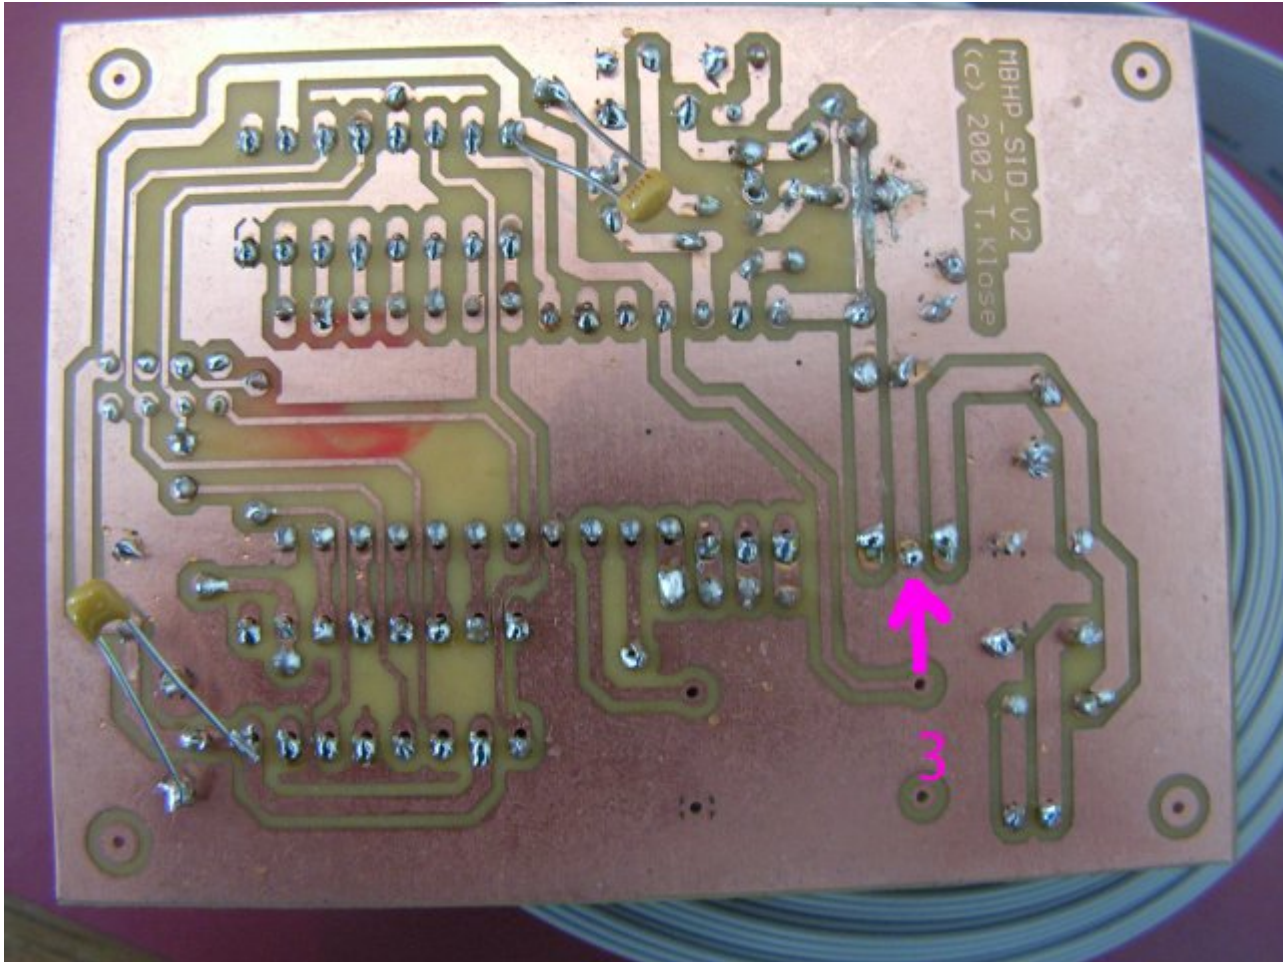
3: this seems to be a bad ground connection directly at the 78xx - it can lead to the wrong voltage. Here the same: just solder the pads again, it will help

And same like above: the long cap legs need to be cutted, the danger for shorts is too high!
