This gallery shows some pictures of bad solderings - they should prevent you from making the same errors (feel free to add even more pictures here!)

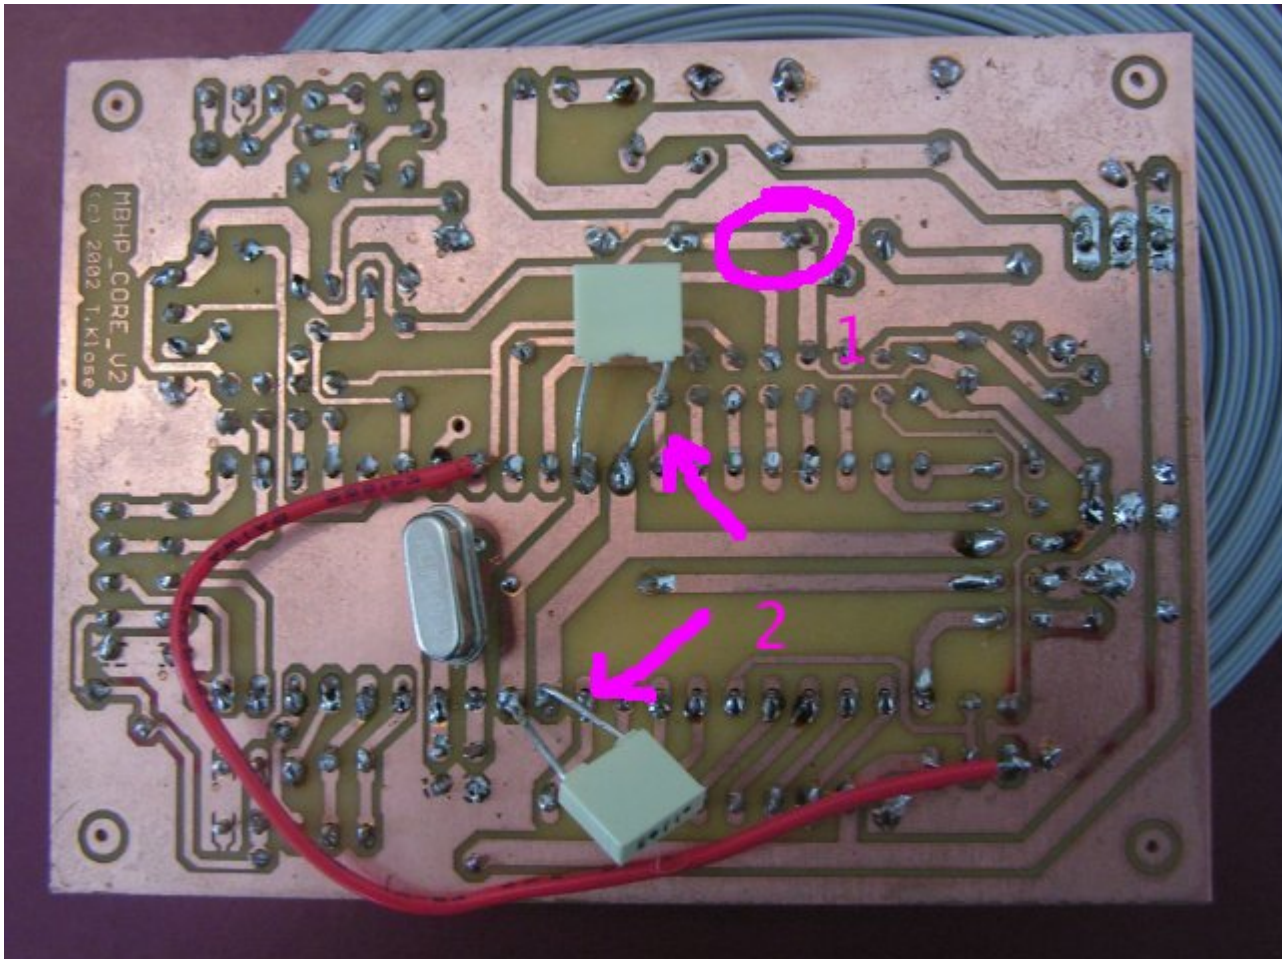
1: The core module has some badly soldered connections(loose), which could lead to failures. There are also missing solderings (e.g. 33pF cap below crystal). It makes sense to solder each pad again, the [Soldering](#) guide in the Wiki gives some useful tips

2: The legs of the caps should be cut, otherwise they can cause a short circuit which can damage the PIC!

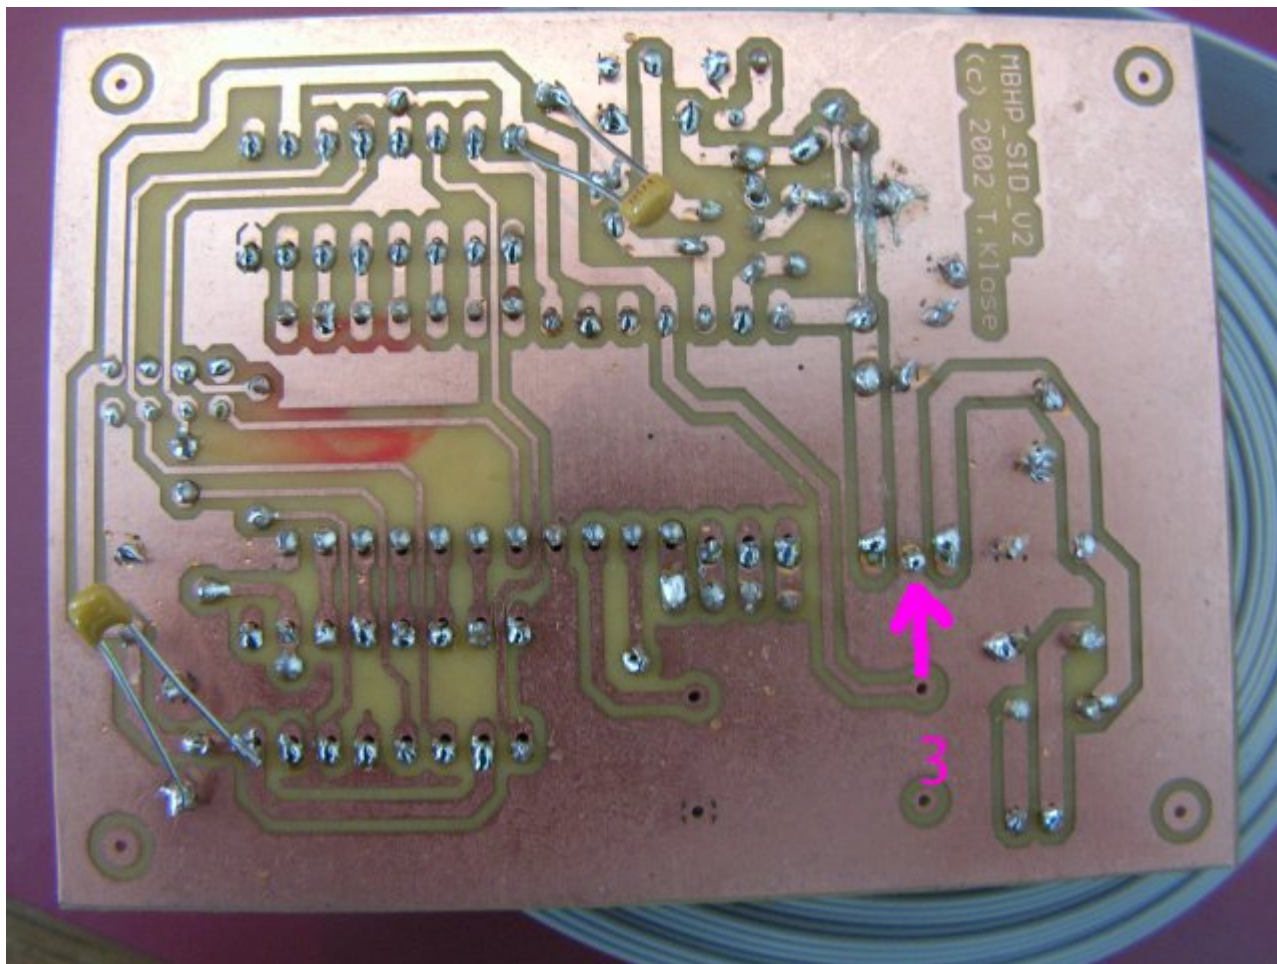
3: This seems to be a bad ground connection directly at the 78xx - it can lead to the wrong voltage. Here the same: just solder the pads again, it will help

And same as above: the long cap legs need to be cut, the danger of shorting out is too high!
