This gallery shows some pictures of bad solderings - they should prevent you from making the same errors (feel free to add even more pictures here!)

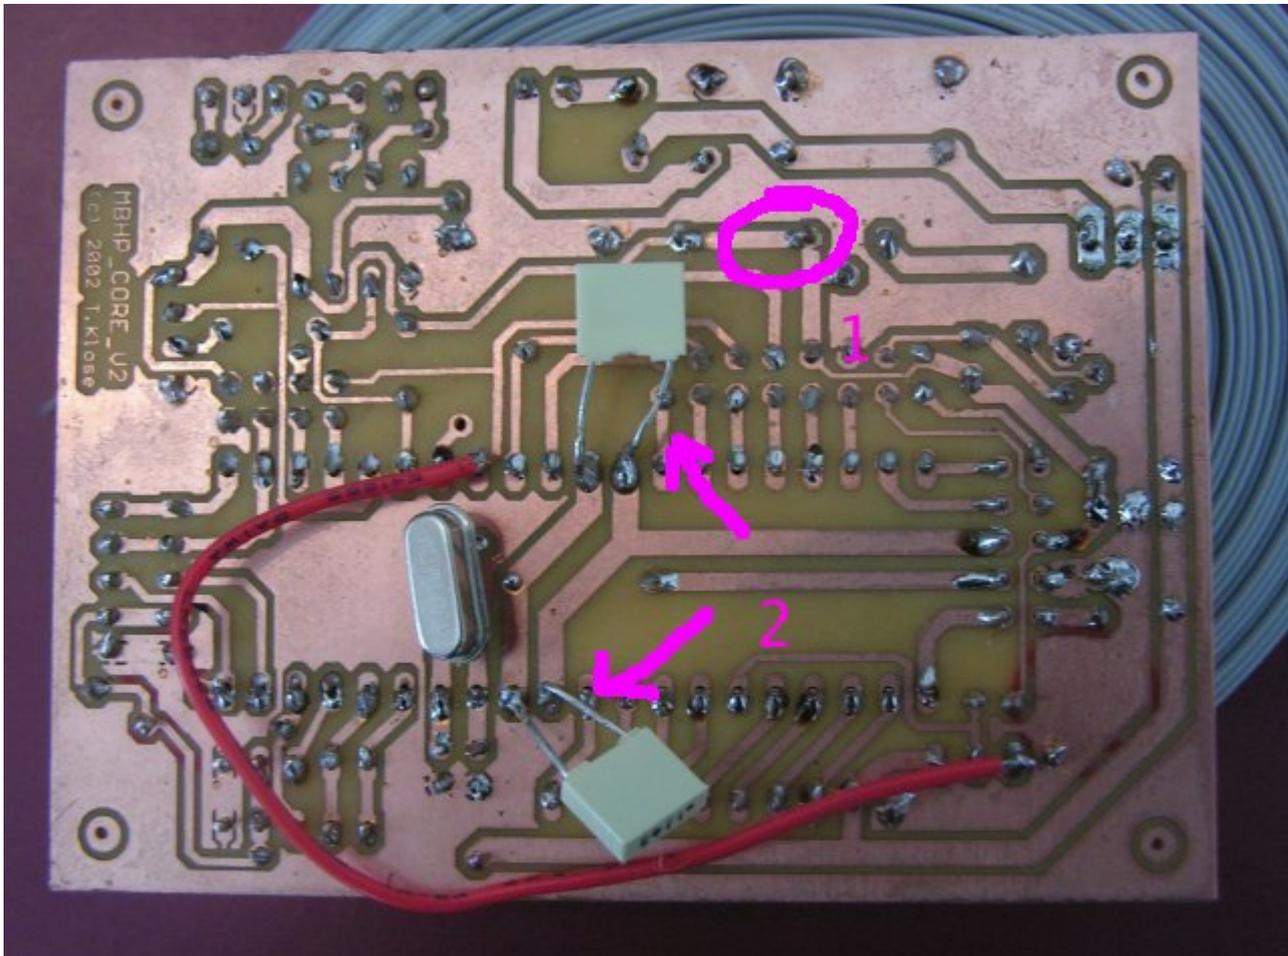
1: The core module has some badly soldered connections (loose), which could lead to failures. There are also missing solderings (e.g. 33pF cap below crystal). It makes sense to solder each pad again, the [Soldering](#) guide in the Wiki gives some useful tips

2: The legs of the caps should be cut, otherwise they can cause a short circuit which can damage the PIC!

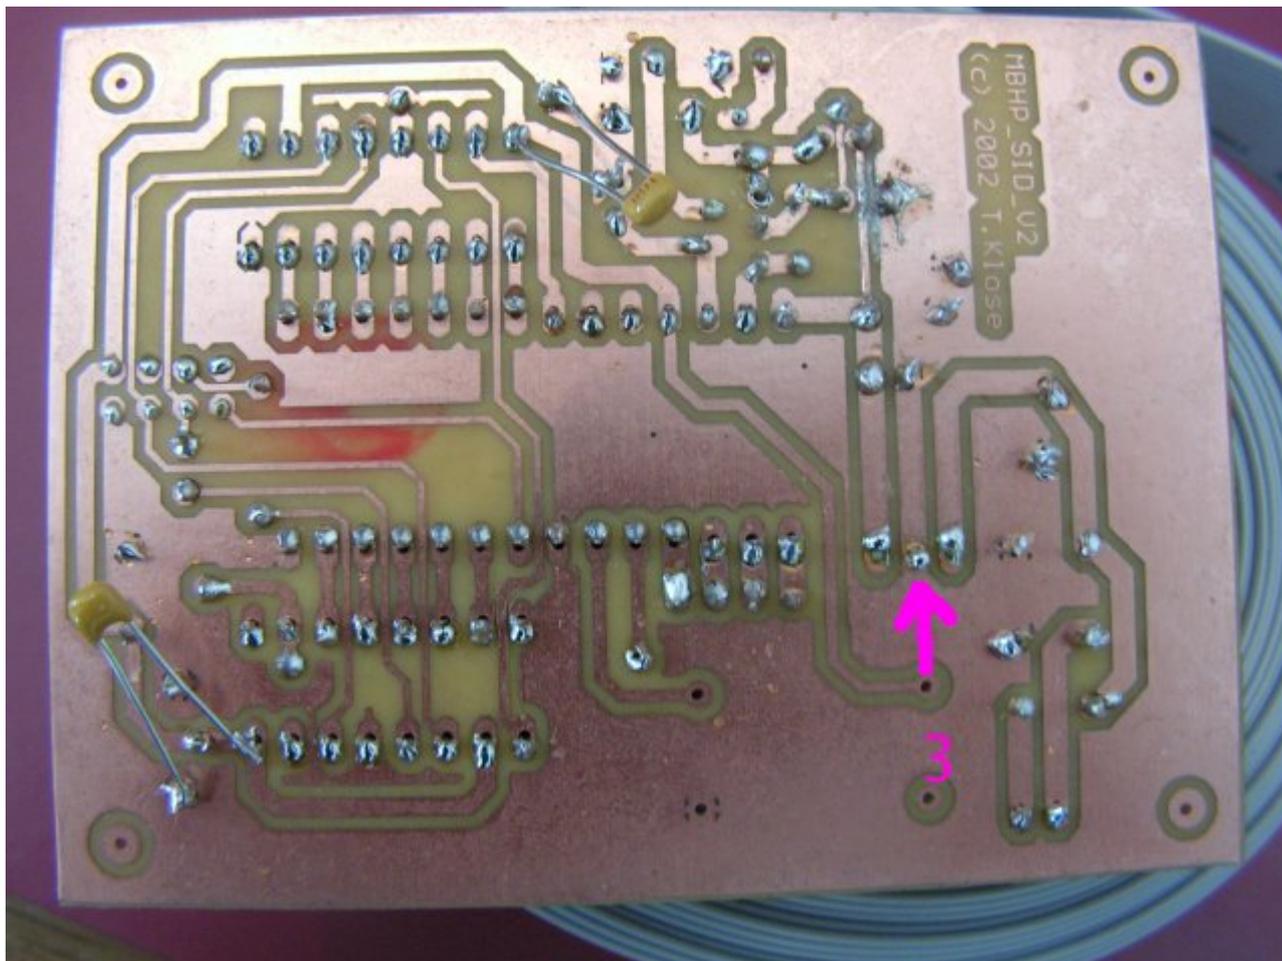
3: This seems to be a bad ground connection directly at the 78xx - it can lead to the wrong voltage. Here the same: just solder the pads again, it will help  
And same as above: the long cap legs need to be cut, the danger of shorting out is too high!
