This gallery shows some pictures of bad solderings - they should prevent you from making the same errors (feel free to add even more pictures here!)

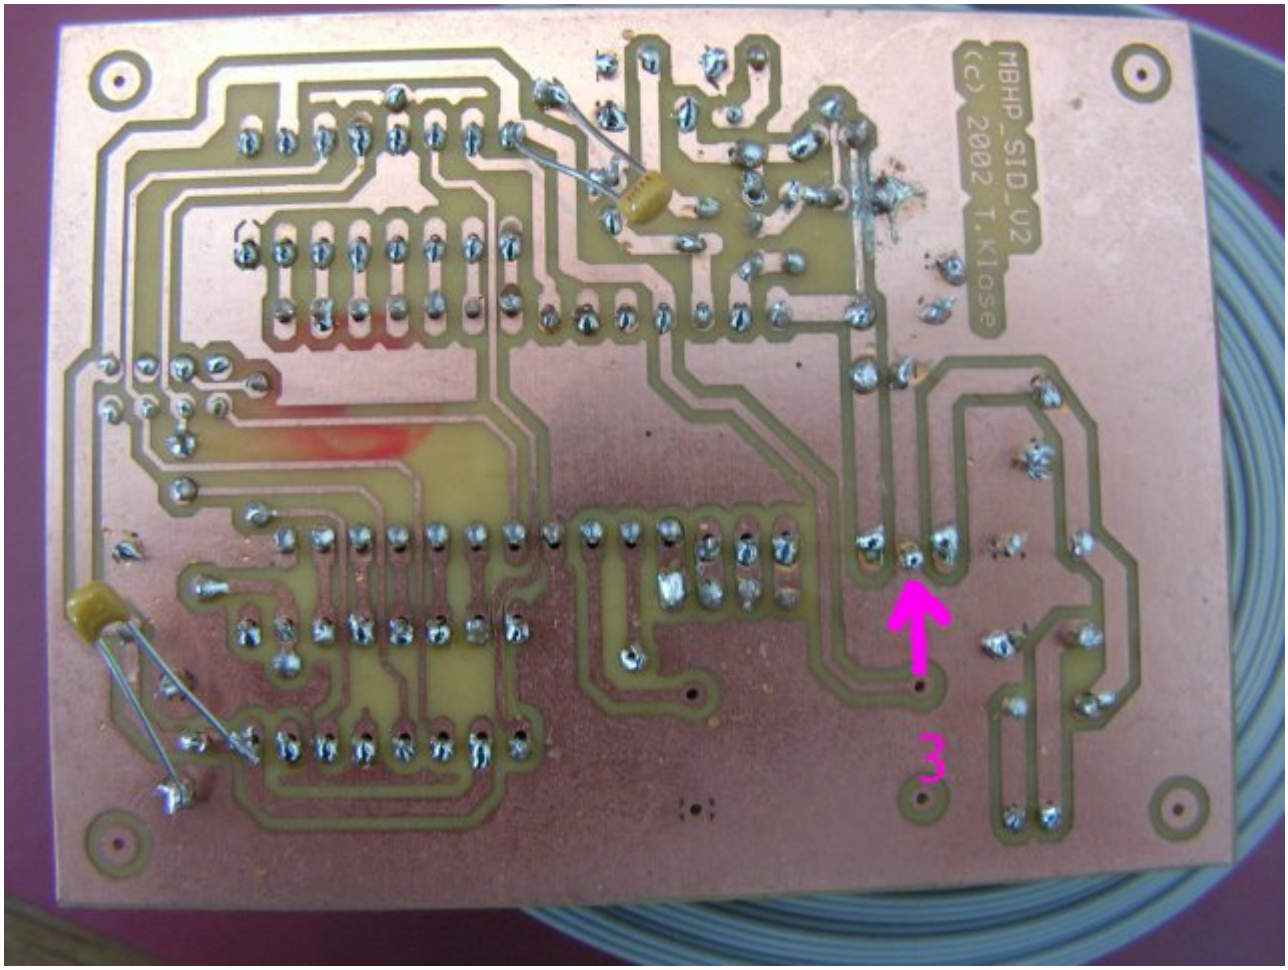
3: this seems to be a bad ground connection directly at the 78xx - it can lead to the wrong voltage. Here the same: just solder the pads again, it will help
And same like above: the long cap legs need to be cutted, the danger for shorts is too high!
