This page lists the know errors on the gm5x5x5 PCBs.

Prototype Run

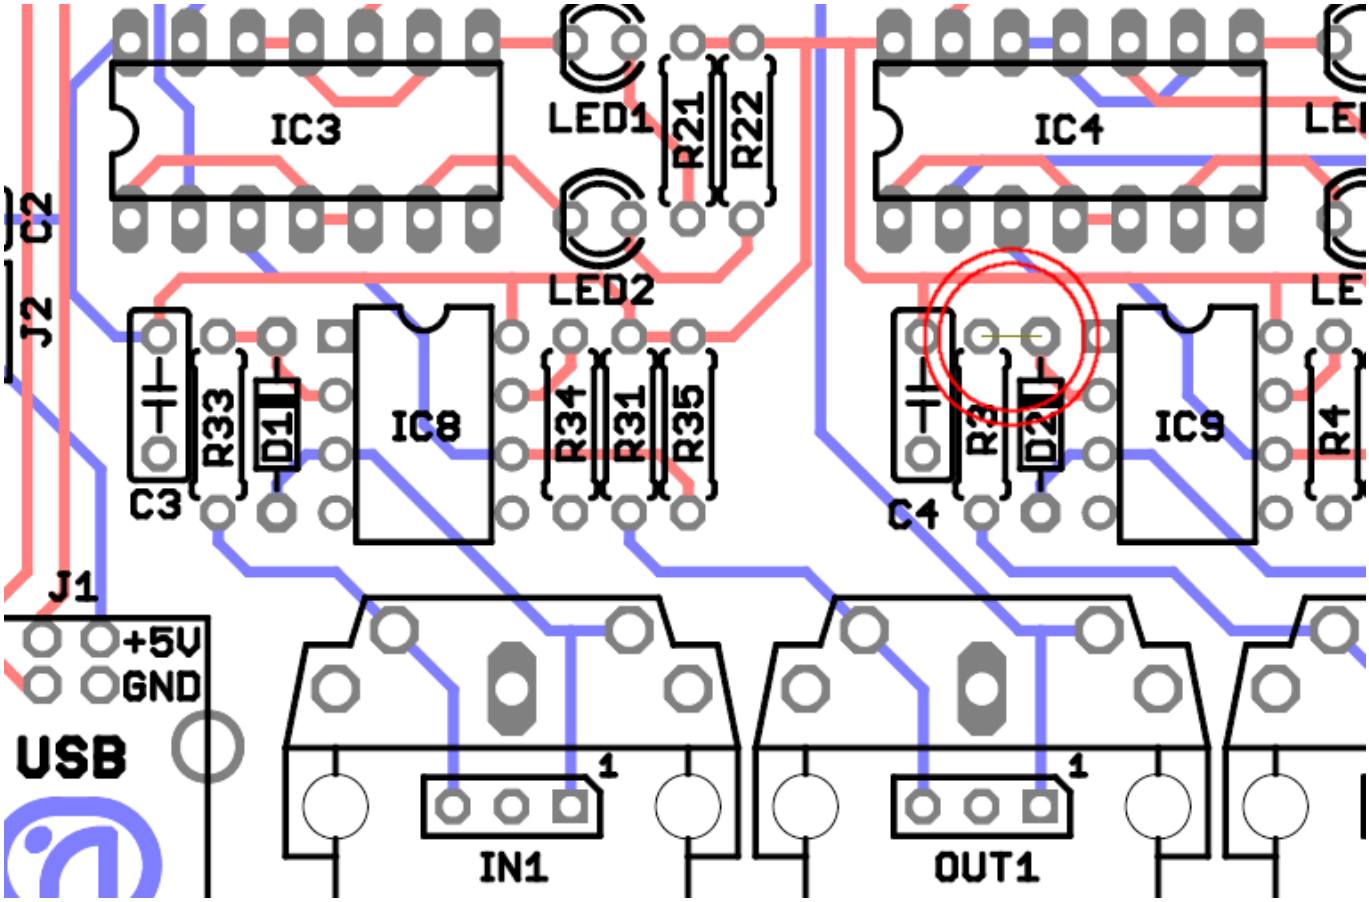
#1 MIDI IO pins

Problem: The MIDI IO pins of the midi sockets (Pin 4 + 5) are switched.

#2 MISSING TRACK

Problem: A track between D2 and R3 is missing.

Solution: Either (1) use the pin-headers if you use sockets that are not mounted on the pcb or (2) break the traces to pins 4 + 5 of the sockets and solder wires to them or (3) solder the midi sockets on the other side of the pcb.

Solution: Bridge the pins.
