Prototype Run

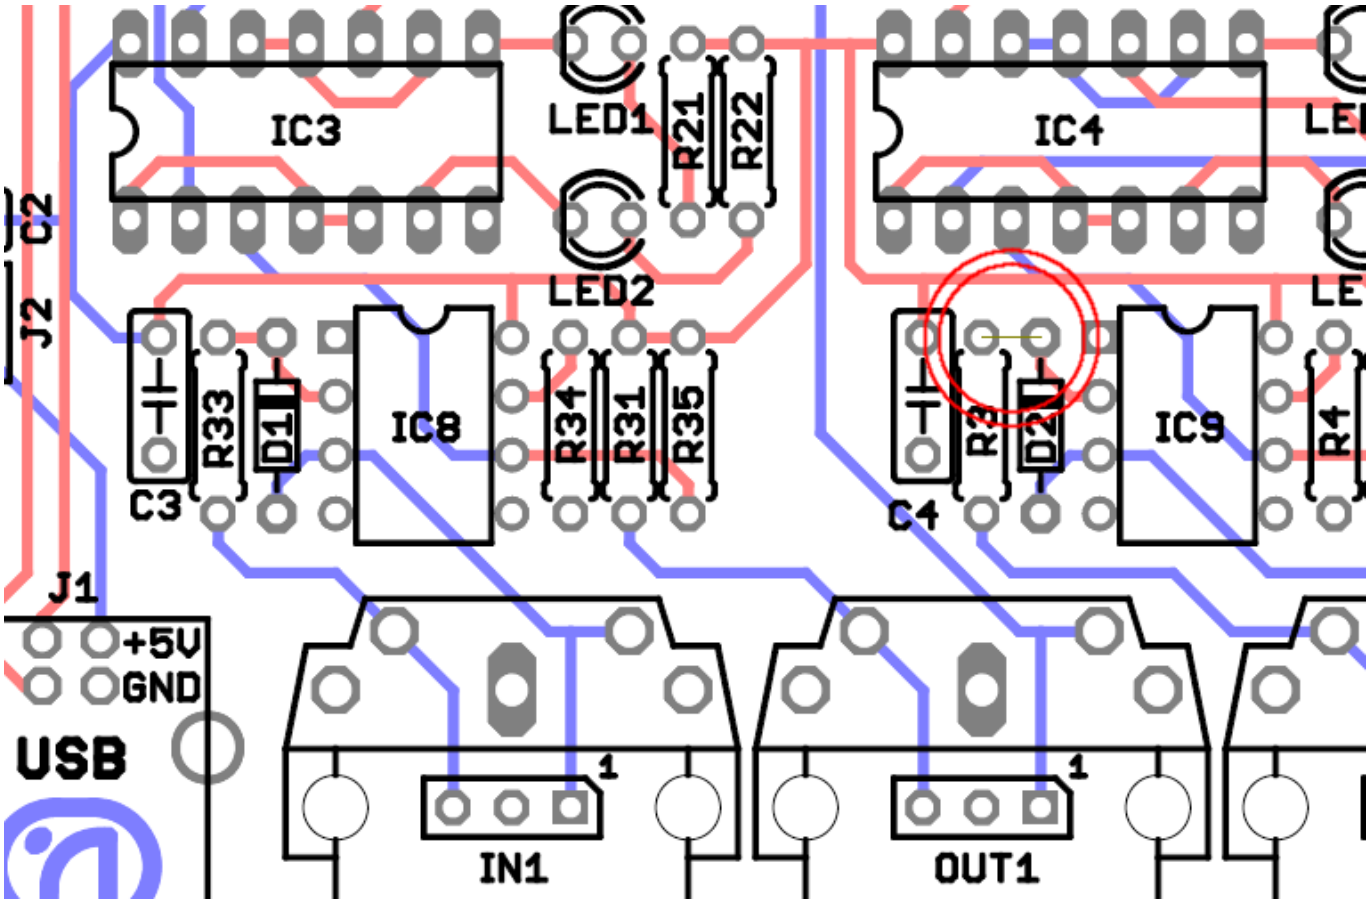
#1 MIDI IO pins

Problem: The MIDI IO pins of the midi sockets (Pin 4 + 5) are switched.

#2 MISSING TRACK

Problem: A track between D2 and R3 is missing.

Solution: Either (1) use the pin-headers if you use sockets that are not mounted on the pcb or (2) break the traces to pins 4 + 5 of the sockets and solder wires to them or (3) solder the midi sockets on the other side of the pcb.

Solution: Bridge the pins.
