This page lists the know errors on the gm5x5x5 PCBs. There are no known issues with the bulk order run (white pcbs), the following information is valid **only** for the prototype run (green pcbs).

Bulk Order #1 (white pcb, rev 1.0)

Prototype Run

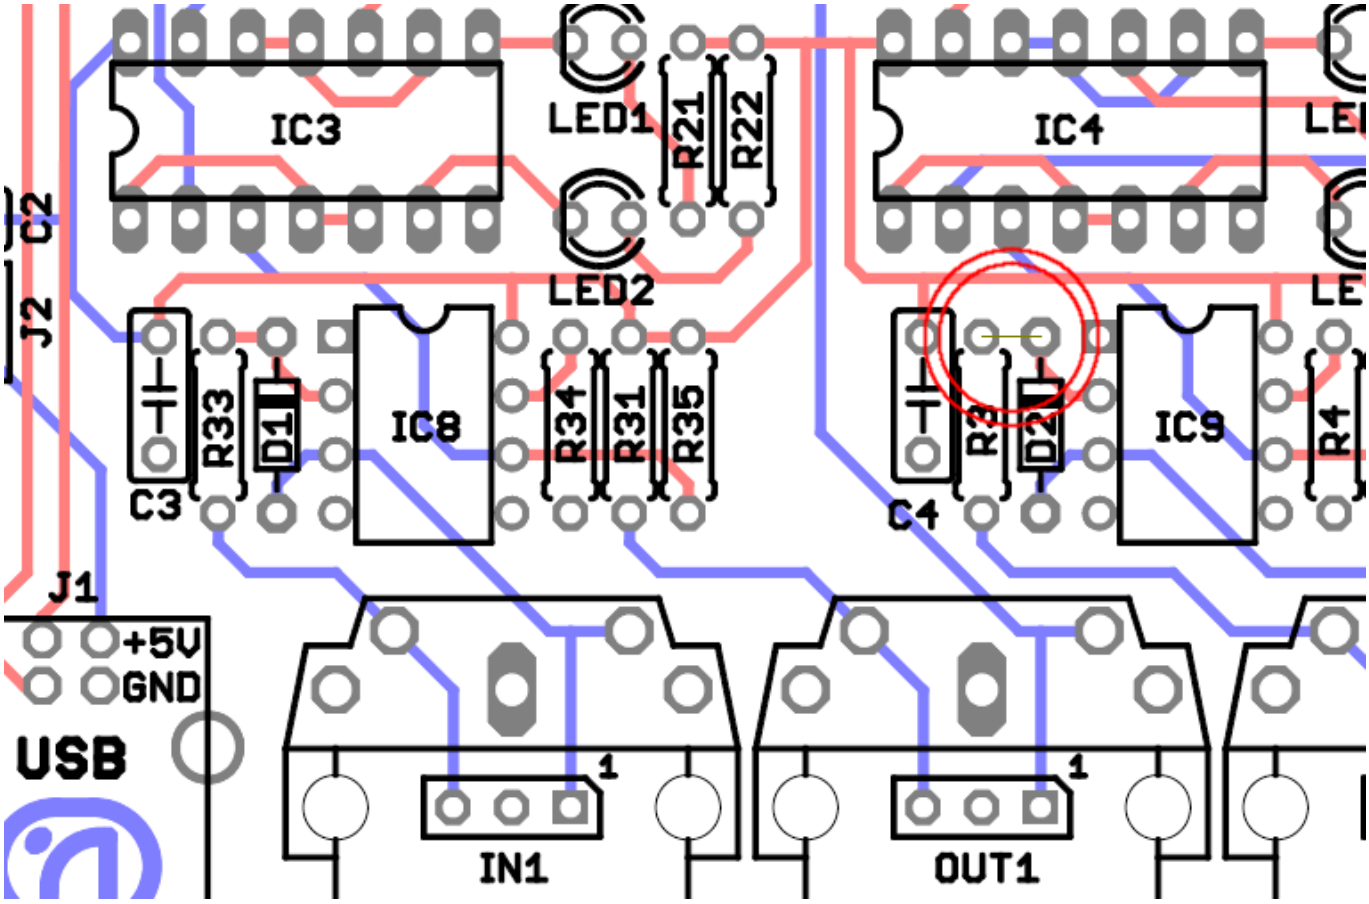
#1 MIDI IO pins

Problem: The MIDI IO pins of the midi sockets (Pin 4 + 5) are switched.

Solution: Either (1) use the pin-headers if you use sockets that are not mounted on the pcb or (2) break the traces to pins 4 + 5 of the sockets and solder wires to them or (3) solder the midi sockets on the other side of the pcb.
